U. S. NAVAL CIVIL ENGINEERING LABORATORY  
PORT HUENEME, CALIFORNIA

# COMPACTED-SNOW RUNWAYS IN ANTARCTICA — DEEP FREEZE 61-64 TRIALS

Technical Report R-399

R. C. Coffin, Jr.

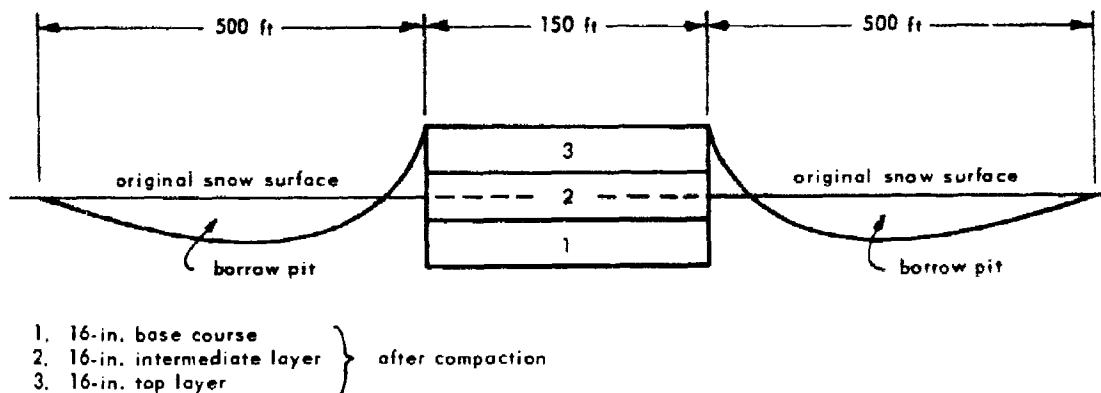
Figure 3. Layered concept of snow compaction.

The initial effort of the DF-62 study was the construction of an experimental elevated runway, 150 feet wide by 5,000 feet long, using the layered-compaction technique. The runway was to overlay the DF-61 test strip on the Ross Ice Shelf and consist of a base course (constructed in DF-61), an intermediate layer, and a top layer or wearing course (Figure 3).

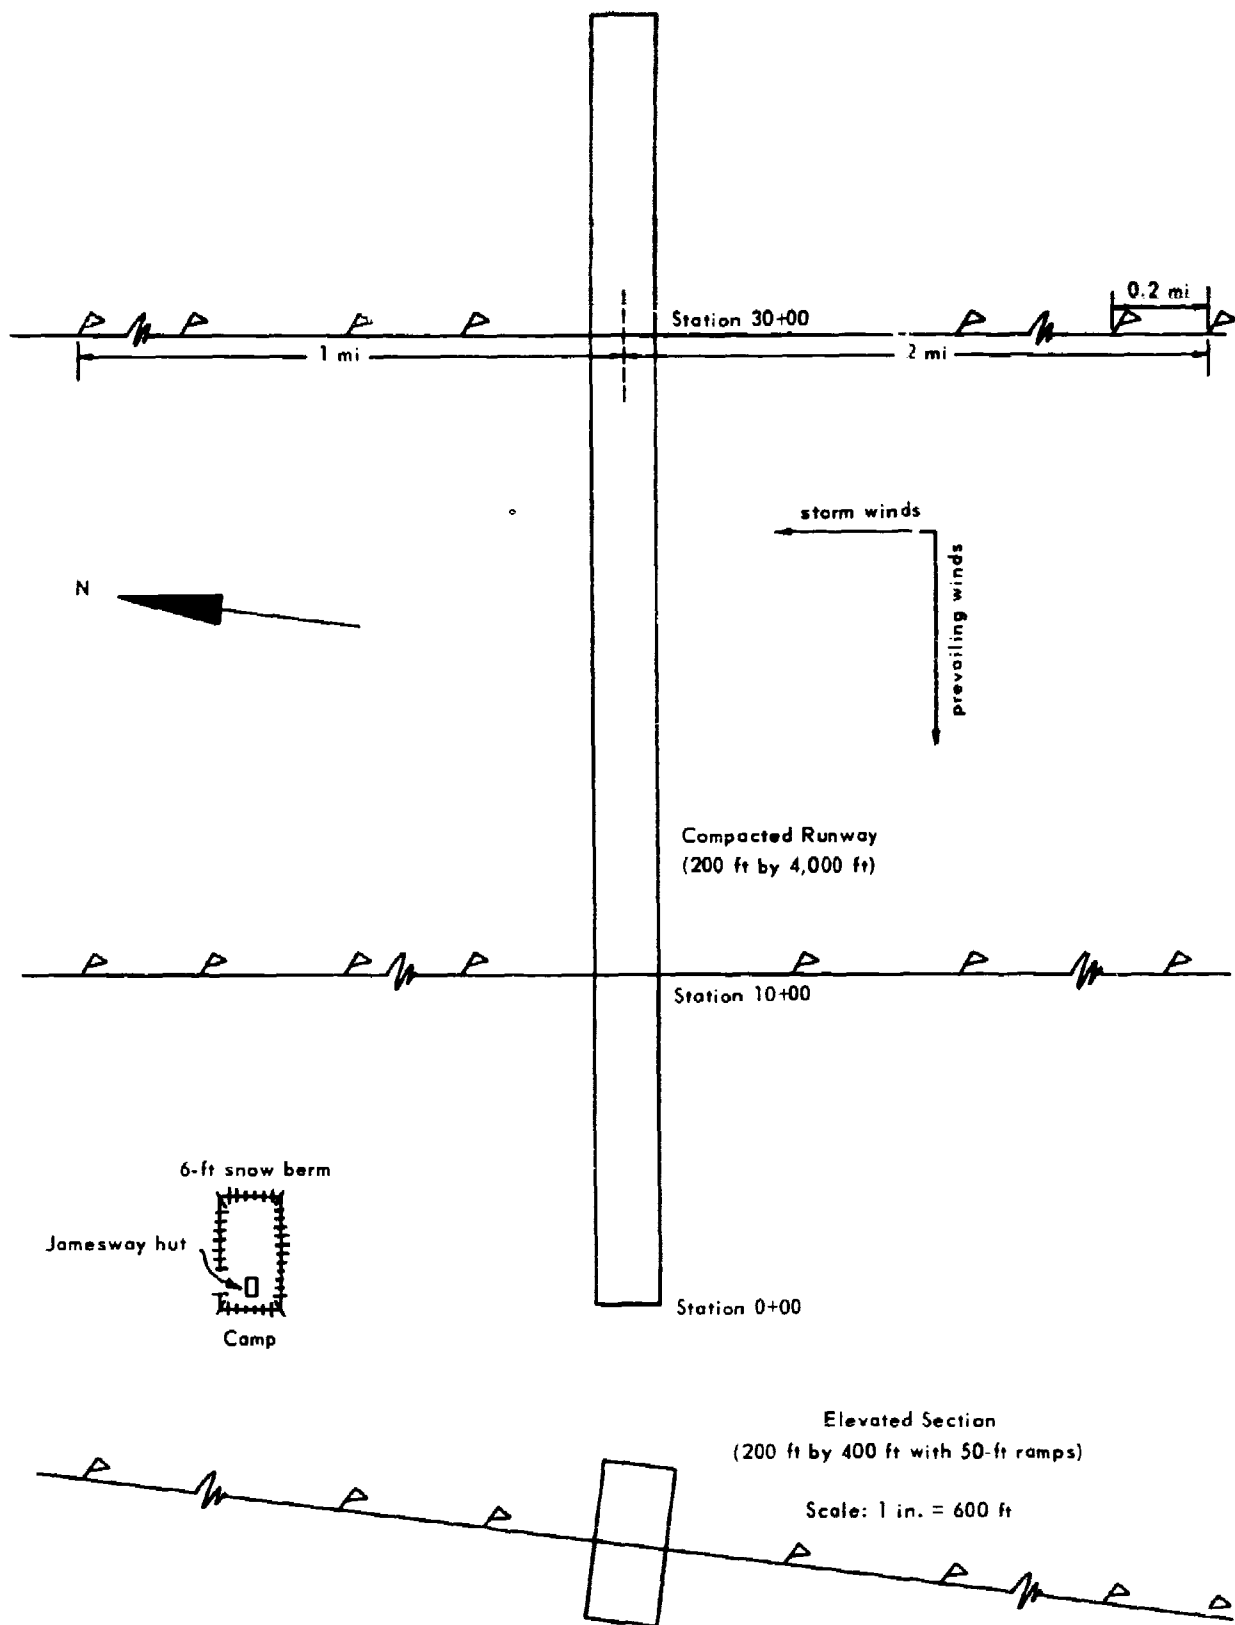
Figure 4. DF-61 test area, with DF-62 drift lines.

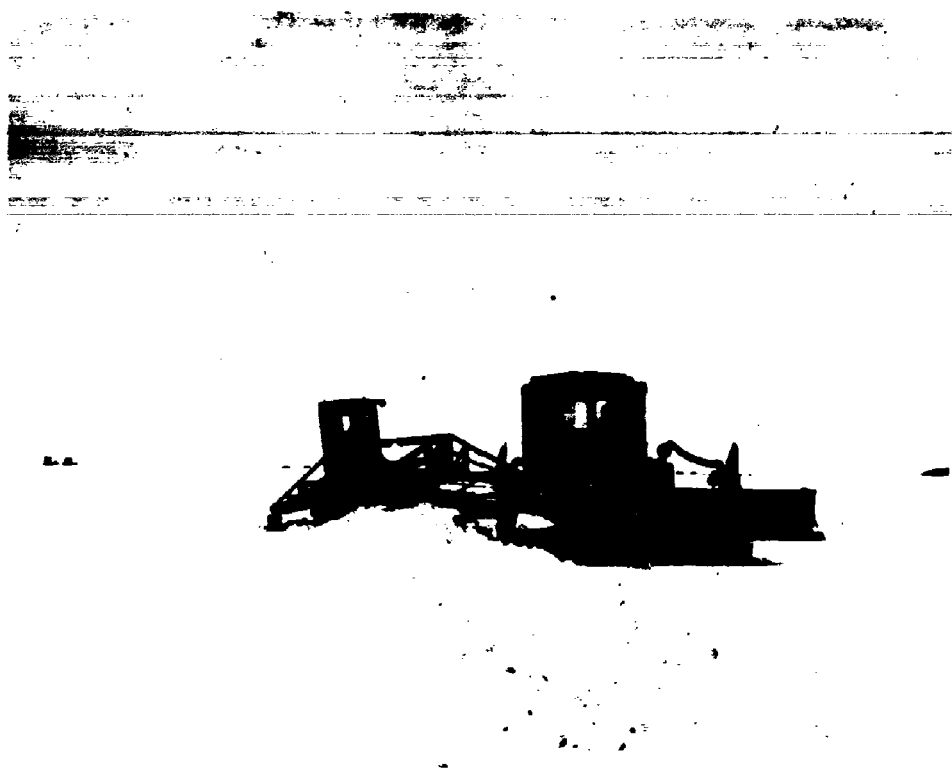
Figure 5. Grading snow for second layer of DF-62 compacted-snow runway.

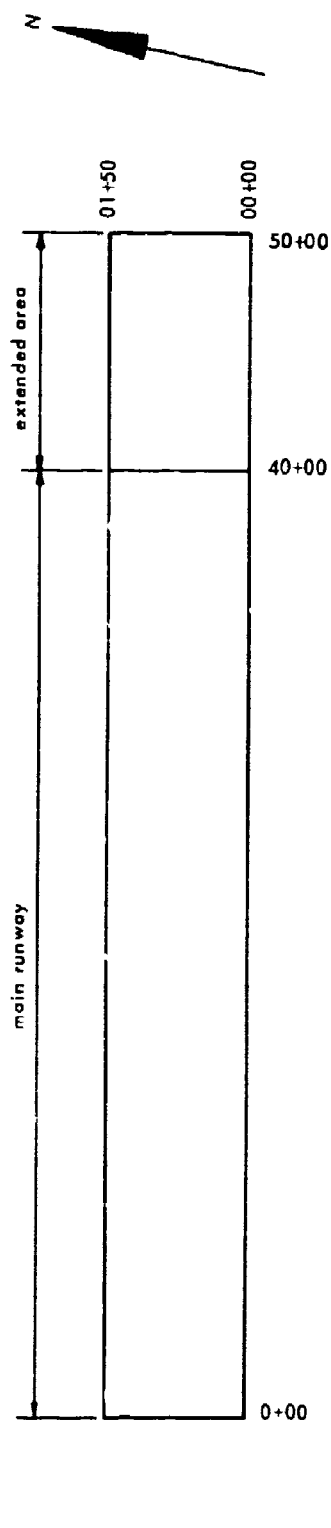
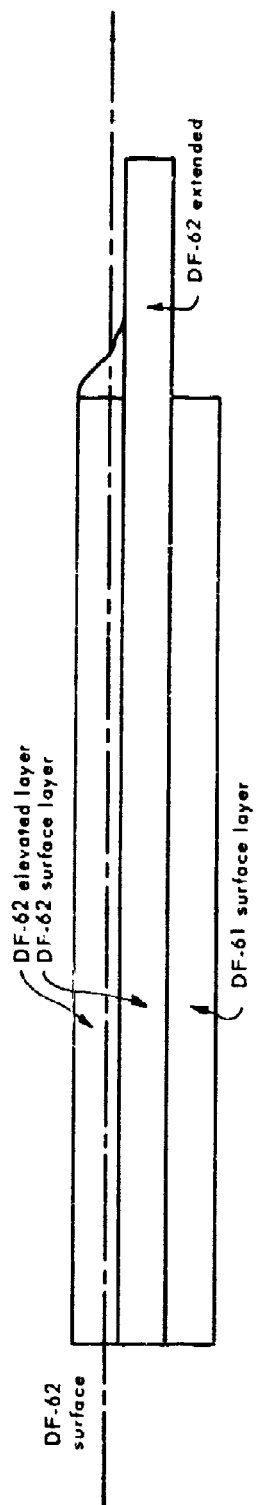
Figure 6. DF-62 compacted-snow runway and extended area.

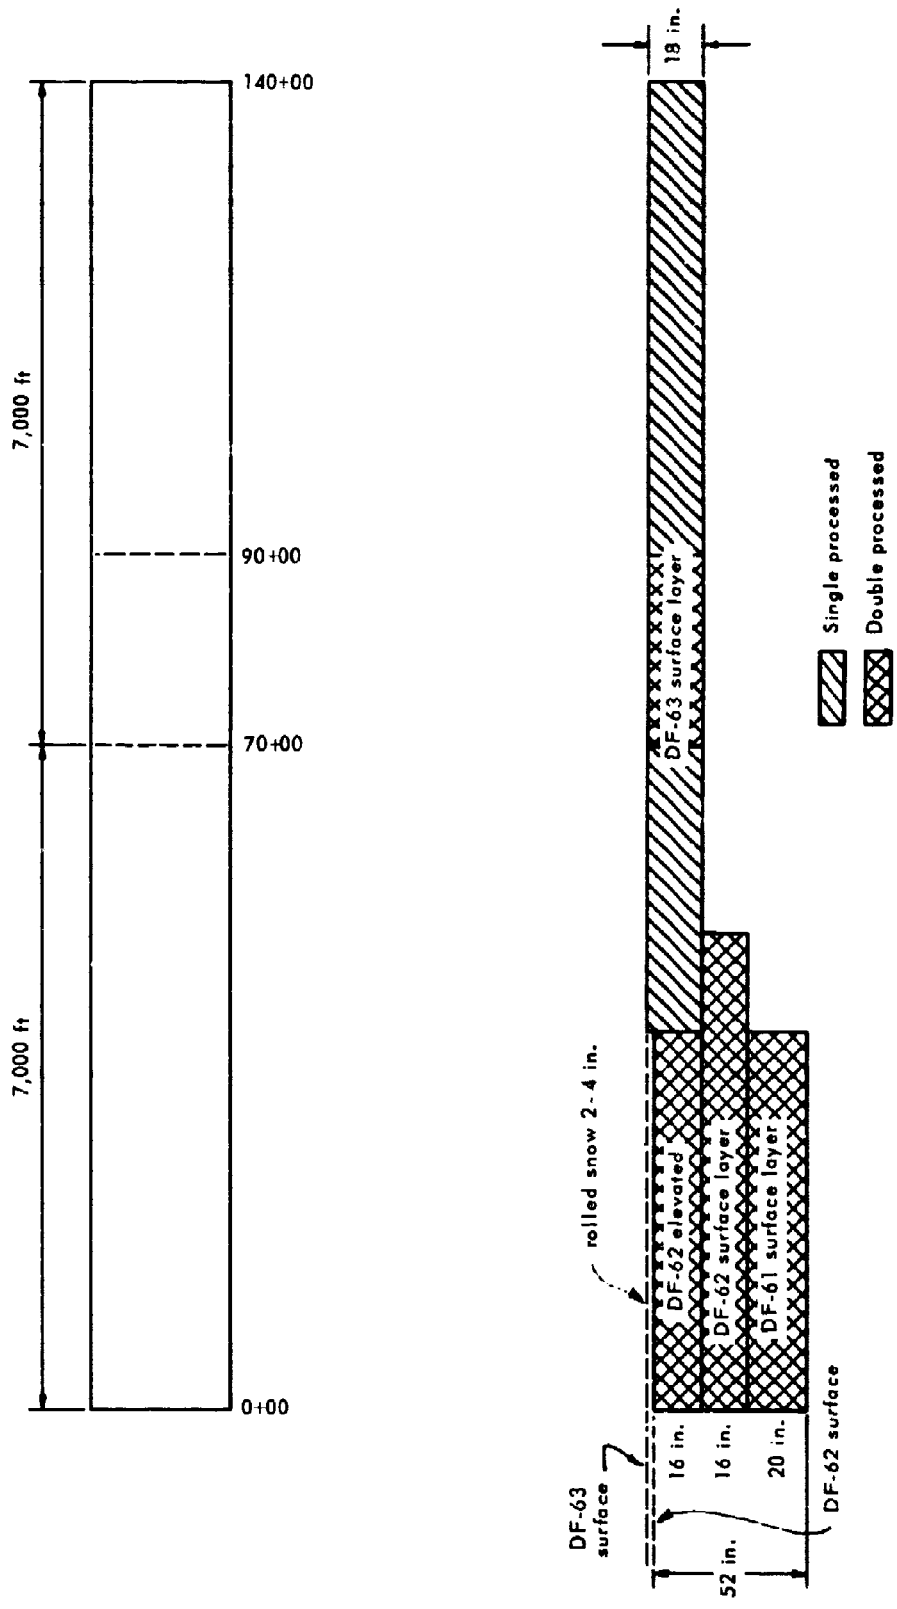
Figure 8. Longitudinal cross-section and plan of the layers processed DF-61 through 63.

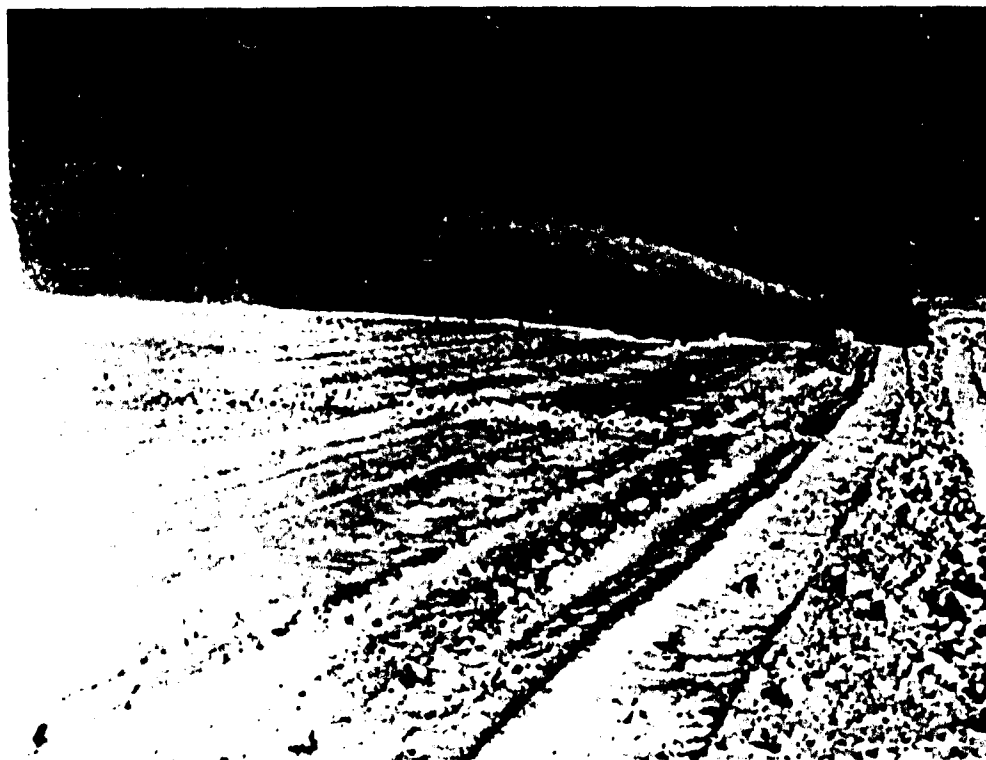
Figure 9. Aerial delivery of fill snow with a tractor-mounted snowplow.

A snowplow was mounted on a standard-gage D8 tractor<sup>13</sup> for the aerial transport of fill snow (Figure 9). From preliminary tests in the NCEL camp area, the following was concluded:

1. The tractor-mounted plow worked best on a fairly level, relatively hard surface.
2. The plow was most effective in fairly loose snow of uniform density and hardness.
3. The standard-gage D8 tractor needed a fairly firm work surface.

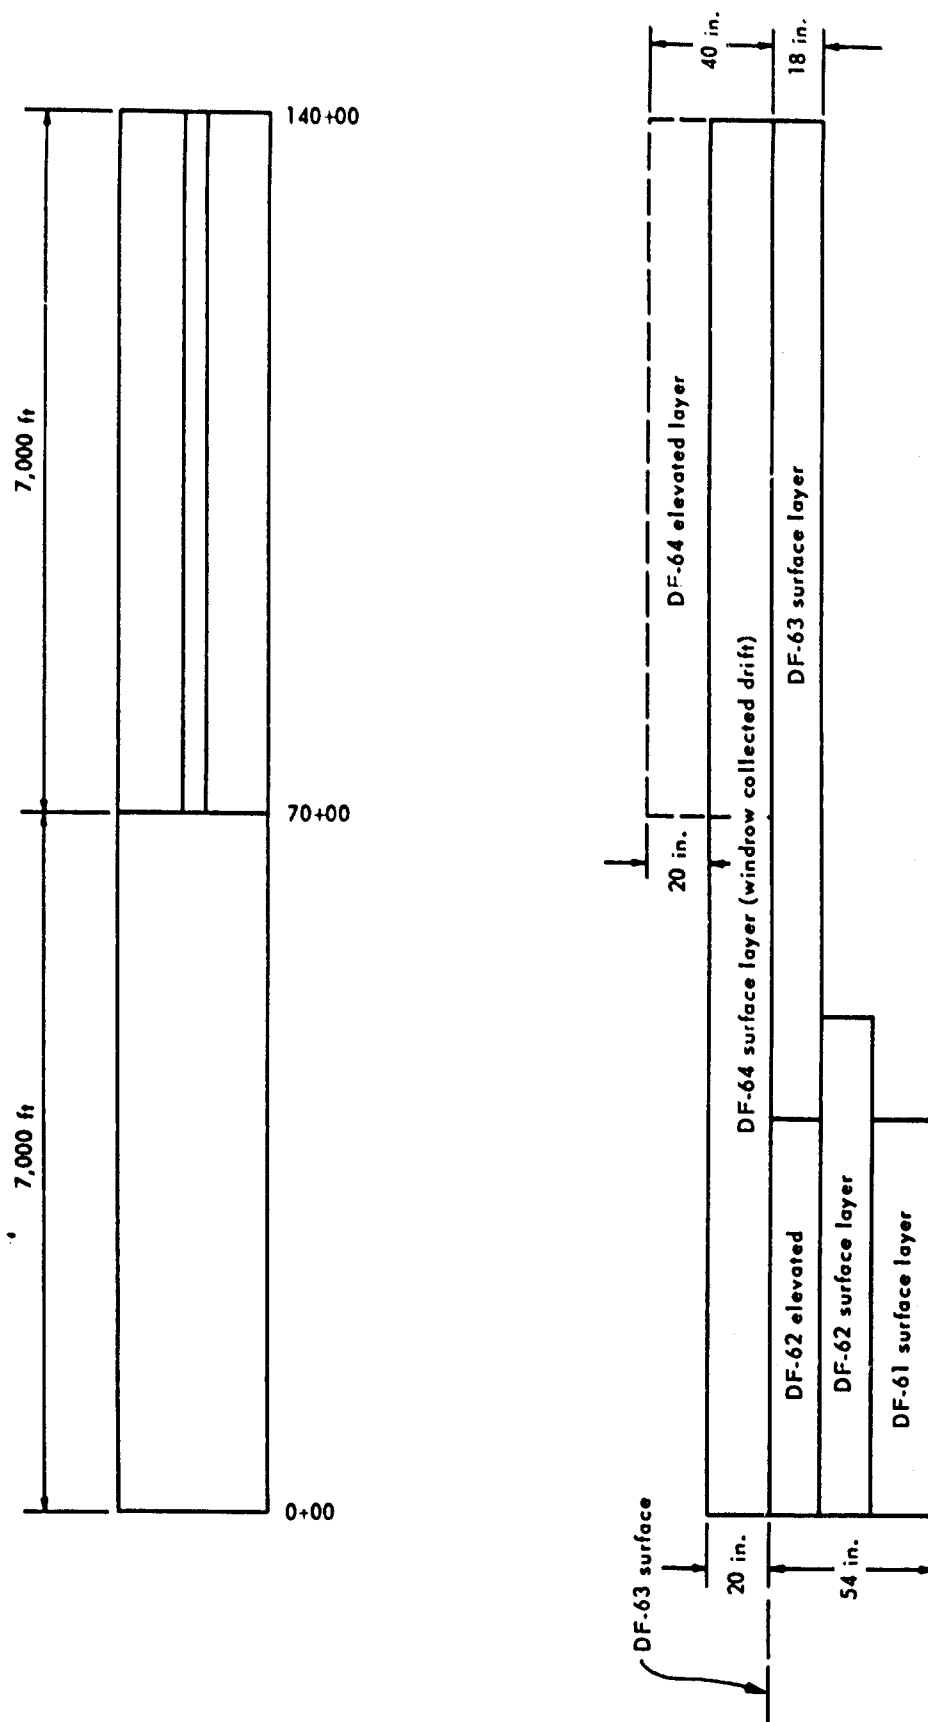
Figure 11. Longitudinal cross-section and plan of the DF-64 test area.

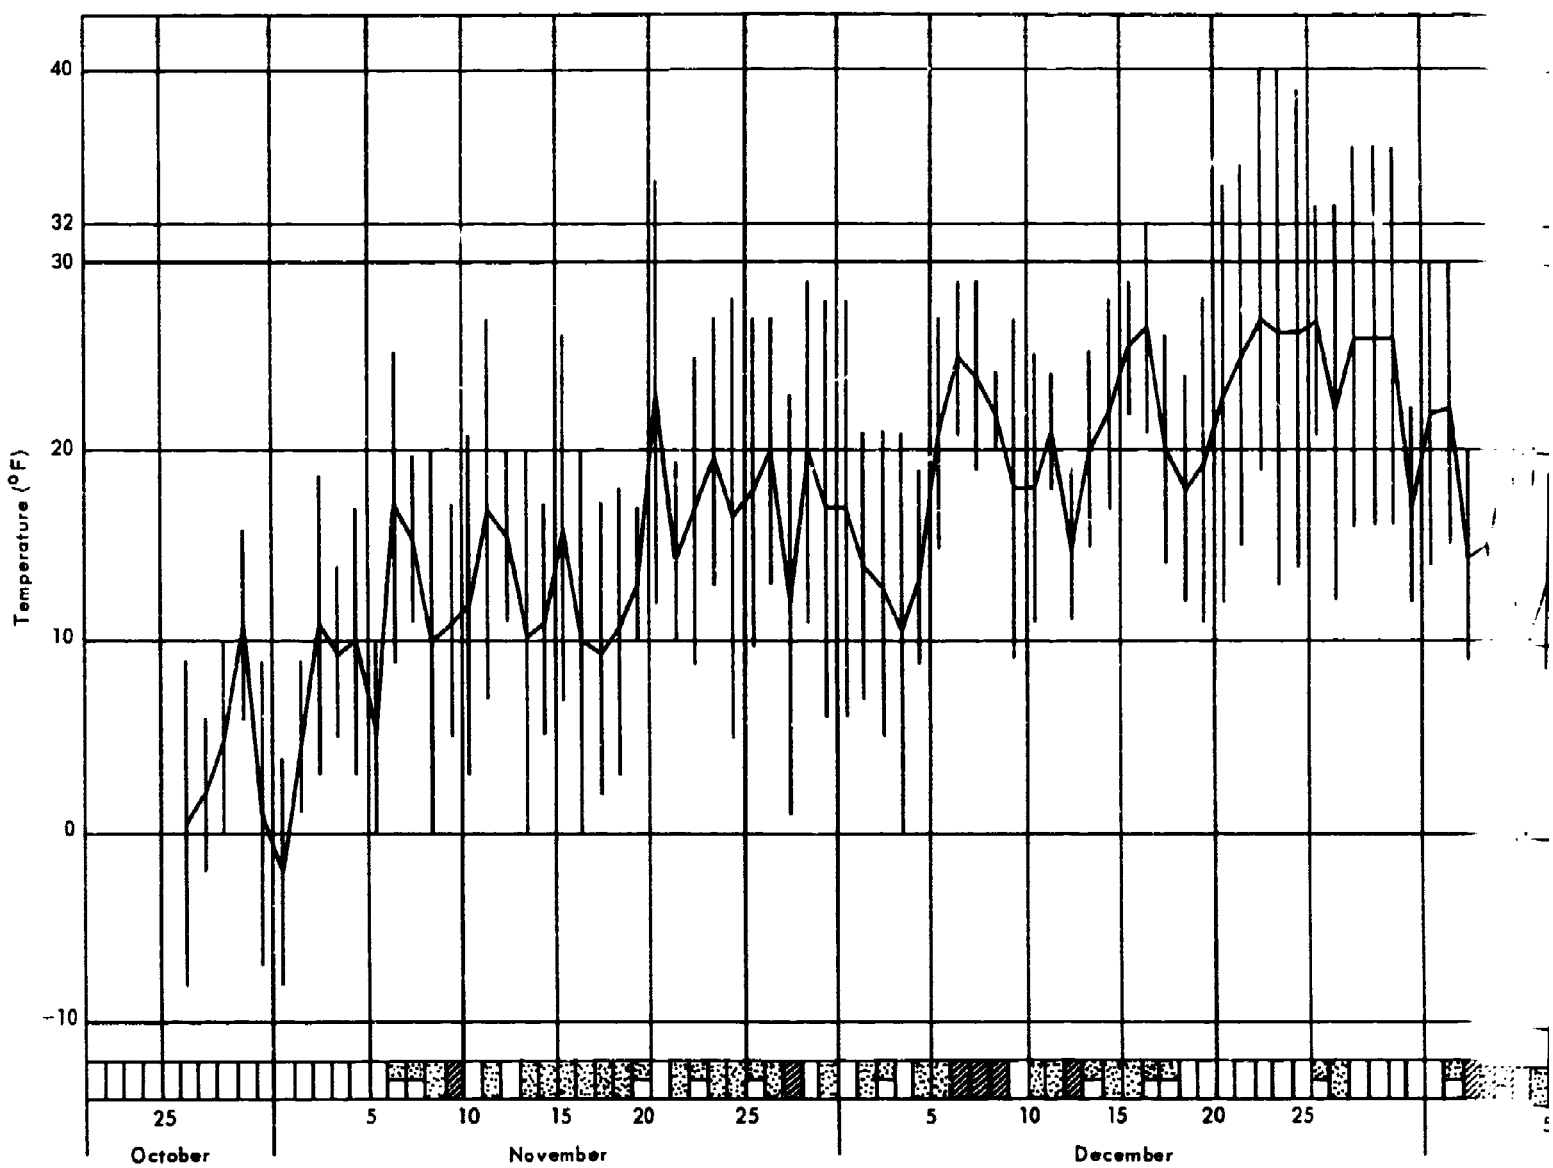
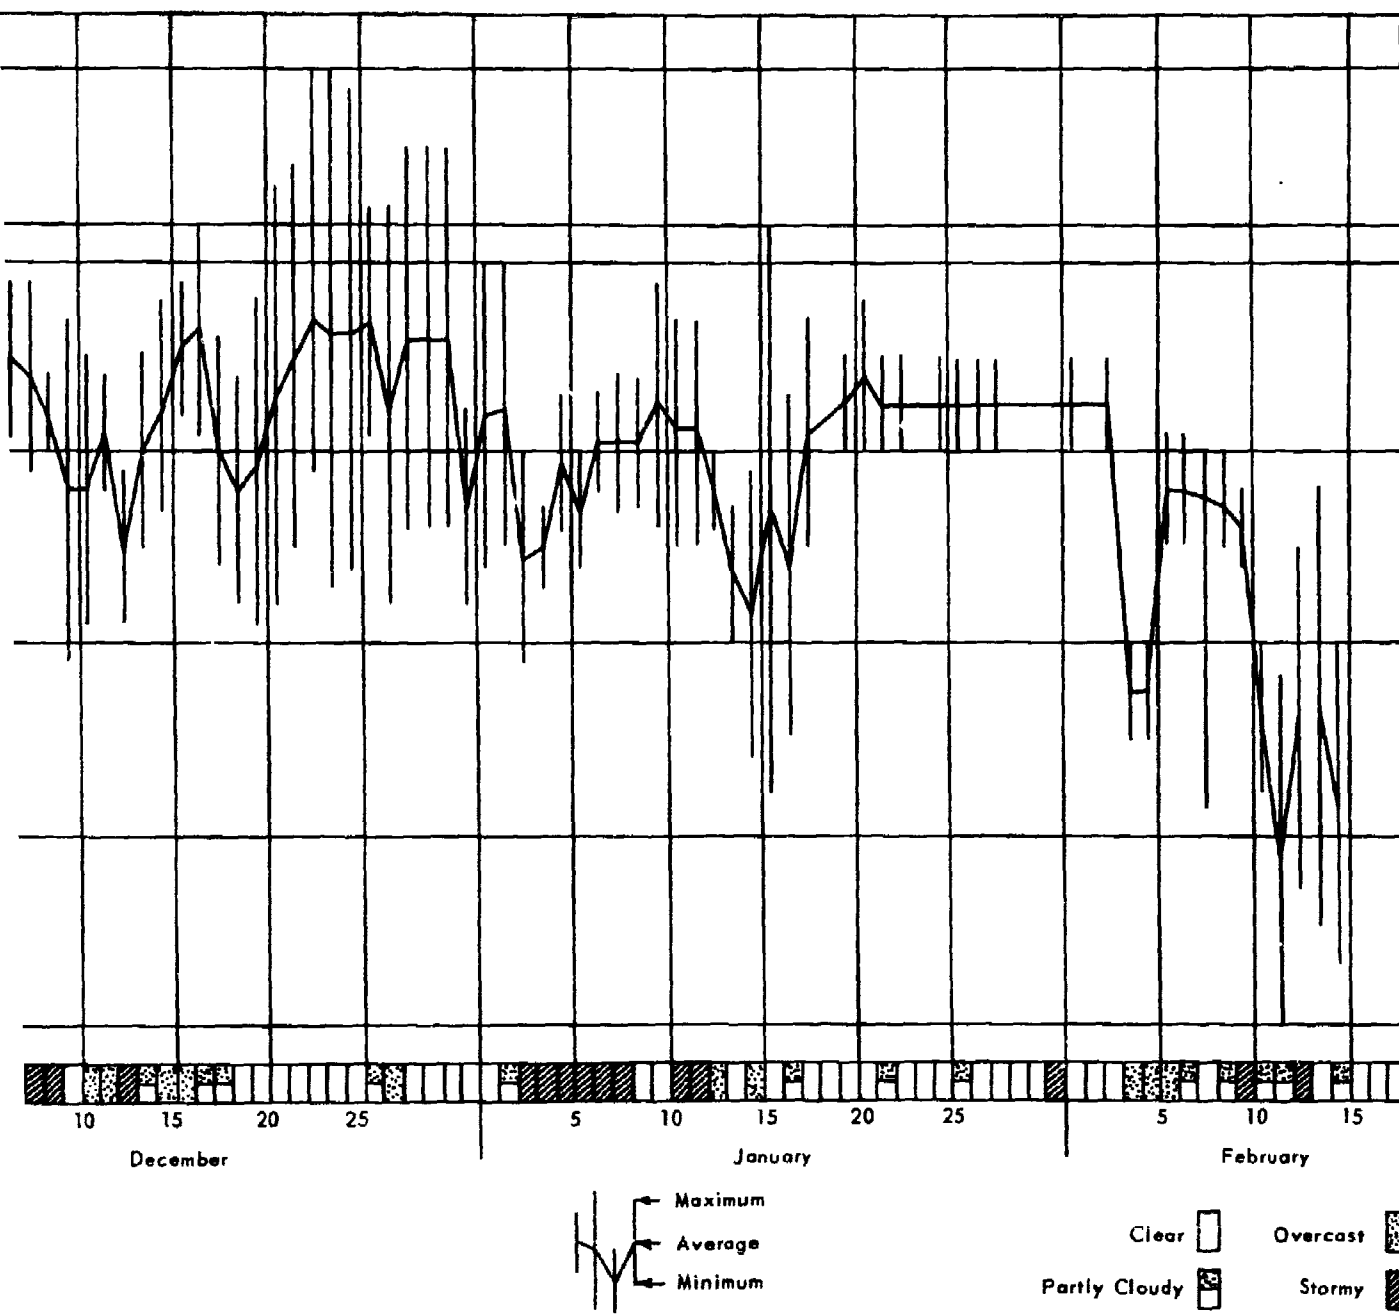
Figure 12. Temperature chart for DF-64.

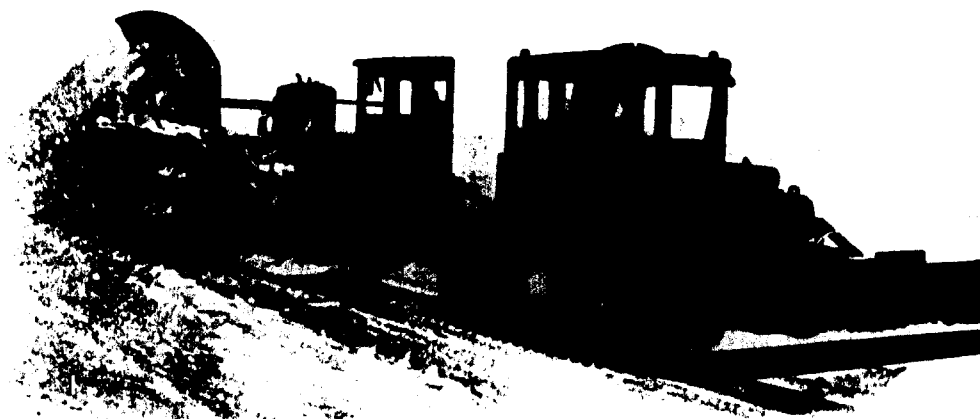
Figure 14. Casting fill snow on the 70 - 140 test area with the Model 40 snowplow carrier.

While the skis were being modified, 10 inches of fill snow was cast on the 70 - 140 runway to bring the total depth of unprocessed snow to 24 inches. The new Model 40, towed snowplow carrier<sup>16</sup> was used to cast the fill snow (Figure 14). Borrow pits for the fill snow were 55 feet wide; they were located along both sides of the test area. With the new carrier, it was found that 1/2 inch of fill could be cast on an 8-foot-wide area at the rate of 167 fpm. This was much faster than any previous technique used for mechanically elevating a compacted-snow area.<sup>13</sup> Using one transporter, 3 days were required to cast a 10-inch layer of fill snow on the 150-foot-wide, 7,000-foot-long area.

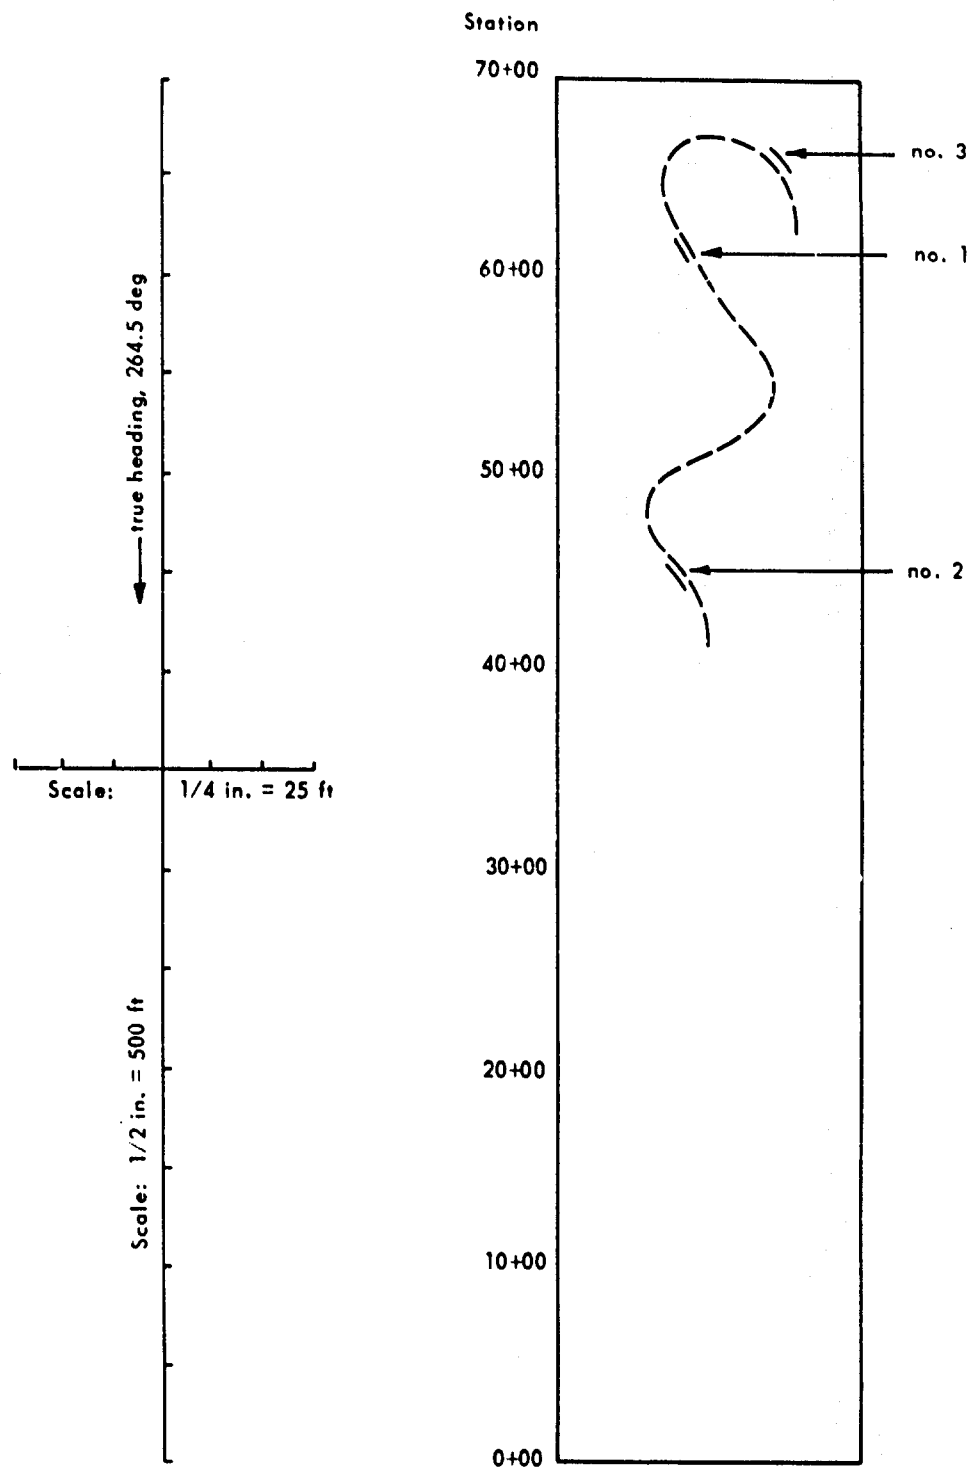
Figure 18. Location of wheel tracks and failure areas during LC-130F taxi tests on 7 February 1964.

Except for three wheel breakthroughs (Figure 18) which occurred between Stations 44+00 and 67+00, the aircraft wheels made little or no indentation on the compacted snow during the 3,400-foot taxi test. Even though the breakthroughs, consisting of 20- to 100-foot-long ruts, represented less than 3% of the total taxi run, they were sufficient to classify the test as a failure.

The areas around the failures were tested for hardness and shear to determine the minimum thickness and bearing capacity required in compacted snow to support the tandem main wheels on an LC-130F with its tires inflated to 80 psi. Analysis of the data indicated that the 8- to 10-inch-thick layer of processed snow over the holiday areas in the DF-64 layer failed where the average hardness of the snow was 460R or less. Where the average hardness in this snow ranged between 470R and 480R, support was marginal and where it averaged 490R or more, no failures occurred. Shear tests indicated that the average bearing capacity of this 8- to 10-inch layer of snow was 56 psi where its average hardness was 460R, 80 psi where its average hardness was 480R, and 89 psi where its average hardness was 490R. In contrast, at the time of the tests, the hardness in the underlying 18-inch-thick, year-old, DF-63 layer of compacted snow (Figure 11) ranged between 590R and 1900R, for an average of 1245R.
